## The Story of a Tankage Project that Could Fill Volumes

**D**espite Alberta's cold and wet weather, operational interruptions, and revised specs as well as revisions to the project timeline, a Canadian contractor completed what is to date the country's largest tank coatings project, and the contractor did so ahead of schedule and with no lost time accidents in 153,000 hours. The project was undertaken for Calgary-based oil storage and distributor Enbridge, which moves approximately two-thirds of Canada's oil, about two million barrels a day. Coating and lining of the Enbridge Hardisty Contract Tankage Project began in July 2008 and was completed in September 2010.

The project called for internal linings and external coatings for the shells and roofs of 19 new merchant tanks that Enbridge added to its existing tank main-line operation in Hardisty, Alberta. With the largest of the tanks capable of holding 530,000 barrels of oil, the 19 new tanks can contain a combined volume of 7.5 million barrels of oil, enough, according to Enbridge, to fill 48,000 Olympic-sized swimming pools. The coating and lining project was undertaken for oil vapor emission reduction, corrosion prevention,

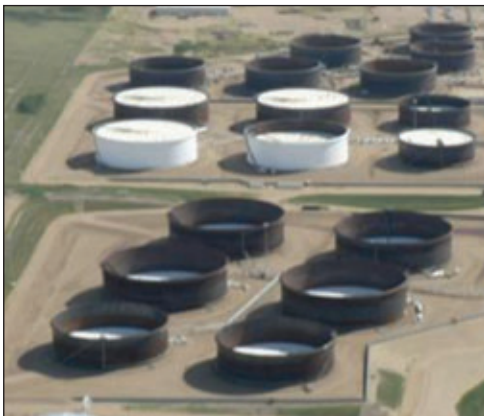
*Below: The coating and lining began in July 2008 when 19 tanks were added to Enbridge's existing main-line operation in Hardisty, Alberta, making the Enbridge Hardisty Contract Tankage Project the largest tank coating and lining job in Canada to date.*

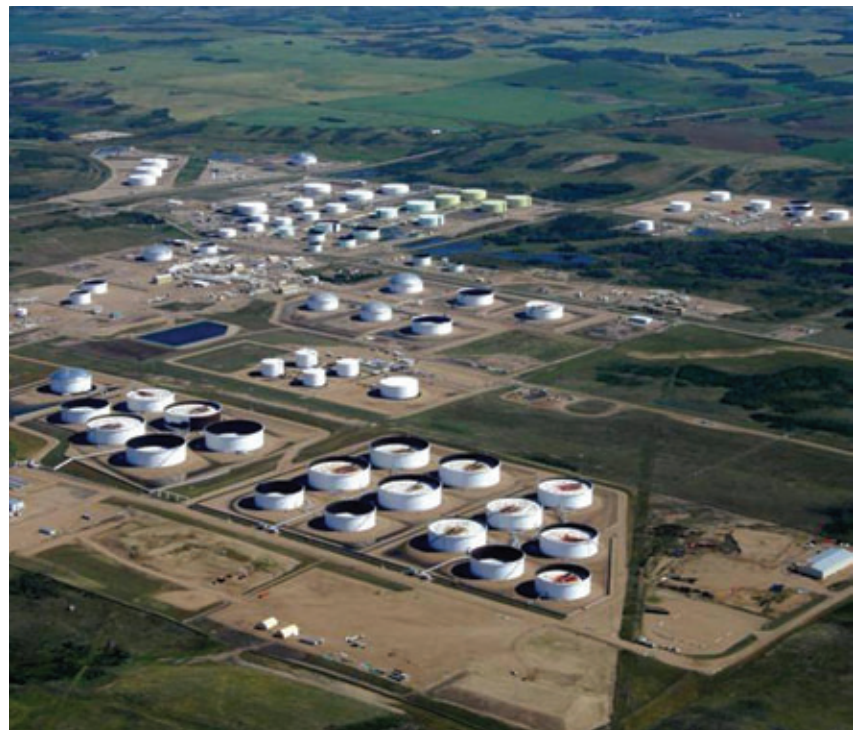
*Right: Overview of the expanded tank main-line operation after the project was completed ahead of schedule, in September 2010. (Dark spots on some tank roofs are either from windblown sand from the surrounding area or minor algae growth.)*

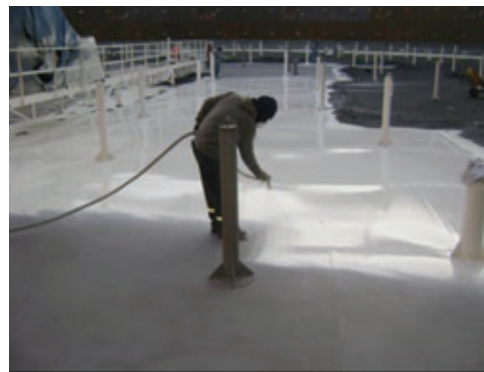
*Worker spray painting roof  
 Courtesy of Park Derochie Coatings Ltd.*

SSPC-SP 6, Commercial Blast, with a surface profile of 2 to 3 mils. The contractor used copper slag and then nickel slag, both of which were specified, but later, with

Enbridge's approval, switched to staurolite for productivity advantages, according to Carriere. Paint crews applied a three-coat system of an epoxy primer (4-6 mils), an epoxy intermediate (4-6 mils), and a urethane finish coat (1.5 to 2.5 mils).

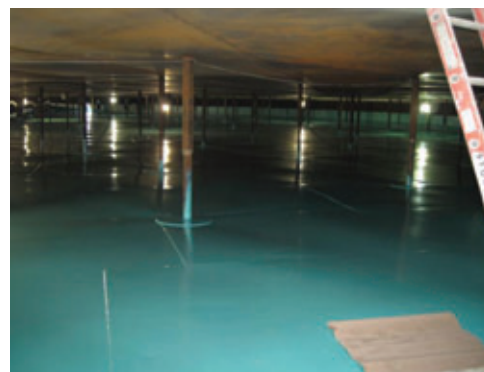
*Tank interior  
 Courtesy of Park Derochie Coatings Ltd.*

humidity, heaters and dehumidifiers were needed to control the environment inside the tank to maintain the correct ambient conditions for blasting and coating. An SSPC-SP 5,

White Metal Blast, with a 3- to 4-mil profile, was specified for the internal floor and first 30 in. above the floor of each tank; one coat of a 100% solids epoxy lining was specified at 30 mils, said Carriere. Above the 30-inch point, the internal

Once each floor was blast-cleaned, a third-party inspector verified that the surface preparation met the spec. The coating crew then stripe-coated welds and edges before applying the 100% solids epoxy lining by plural-component spray. The contractor's NACE-certified inspector and the facility owner's third-party inspector conducted holiday detection testing and final inspection of each lining.

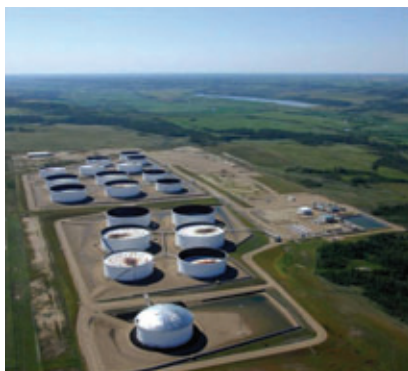
*The new tanks, with coatings and linings performing well  
Courtesy of Enbridge*

The roofs, coated first, show no rust after two years. The tank exteriors show no rust after one year. With the job completed in September 2010, the tanks are now in service.
